# UTAH STATE CAPITOL ARCHITECTURE: INTERIOR IMPACT ZONE SURVEY REPORT

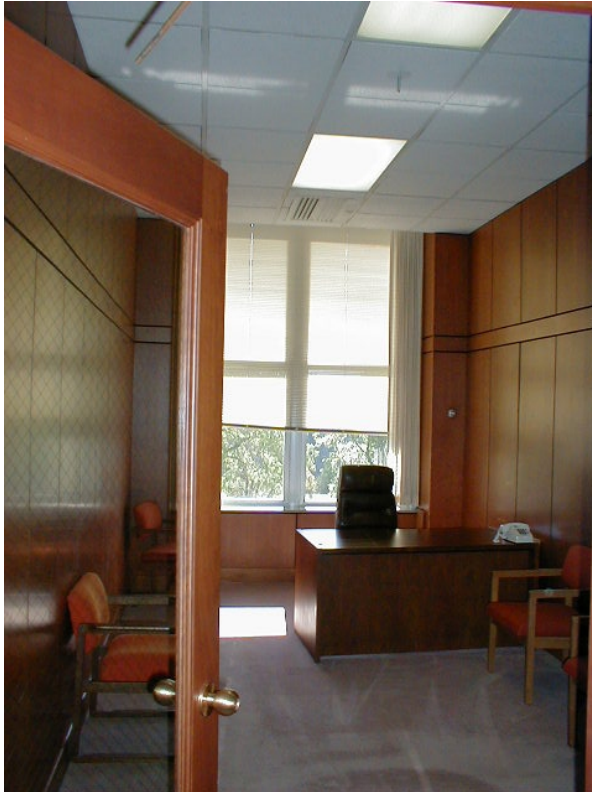
## 344 Vacant Office

Element	Description	Historical Significance	Notes
D-02	Wood panel door, wood bollection molding casing	Contributory Qty:	
D-11	Metal wood-grained panel door with matching casing. Plain louver transom	Contributory Qty:	
D-15	Wood slab door with plain wood casing (simple closet/demountable doors)	Significant Qty:	
SP-3	Wood bookcase, built-in	Non Contributory Qty:	
W-4	Wood panelled wall	Contributory Qty:	
WN-1	Aluminum replacement window	Non Contributory Qty:	
B-2	Molded wood base	Non Contributory Qty:	stain - on demountable
W-18	demountable wall	Non Contributory Qty:	West Wall only
D-21	Metal wood-grained panel door with matching casing. Banker glass panels in door. Plain louver transom	Significant Qty:	
L-08	Fluorescent lights	Non Contributory Qty:	
CL-08	Acoustical ceiling, suspended T-bar frame	Non Contributory Qty:	
B-2	Molded wood base	Contributory Qty:	
D-20	Wood panel door with wood bollection molding. Wire glass panels	Contributory Qty:	marble threshold, 3' sidelights, interior transom. - made to look similar to existing wood paneled wall.

CL-08	Acoustical ceiling, suspended T-bar frame	Non Contributory Qty:

<b>D-09</b>	Wood slab door with decorative metal-wood grained casing, transom above	Contributory Qty: 1	with M-6, M-41, H-3, WN-7 to hall
<b>F-11</b>	Carpeted floor, on pad	Contributory Qty:	
<b>L-08</b>	Fluorescent lights	Non Contributory Qty:	
<b>W-4</b>	Wood panelled wall	Non Contributory Qty:	
<b>WN-1</b>	Aluminum replacement window	Non Contributory Qty: 1 pr	with M-16

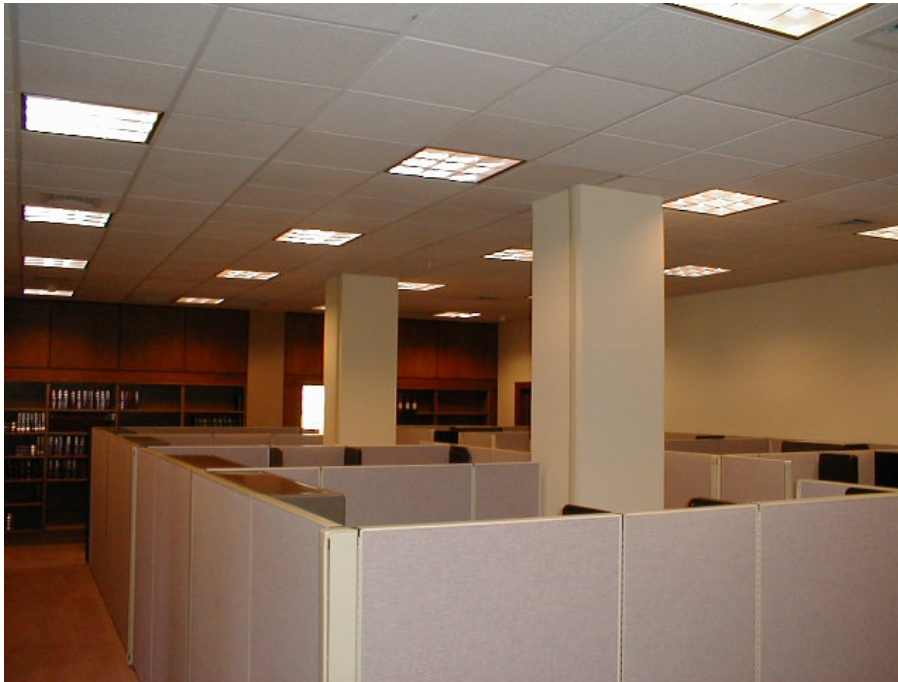
## 360 Senate offices (overflow)

Notes vacant - includes all of 360 - b-I, window element variable , office areas made of systems furniture  
CPP  
need photos, in conference room there is a wet bar with basic mill-work.

Element	Description	Historical Significance	Notes
SP-3	Wood bookcase, built-in	Non Contributory Qty:	
W-18	demountable wall	Non Contributory Qty:	have window transoms/side lights. Oak finish.
W-11	Fabric wall, glue-on	Non Contributory Qty:	
B-12	Carpet base	Non Contributory Qty:	
D-19	Wood slab door with plain metal casing. (demountable wall doors)	Contributory Qty:	with M-19, W-11, to 321
F-12	Carpeted floor, glue-down	Contributory Qty:	custom
L-81	Parabolic	Non Contributory Qty:	
W-4	Wood panelled wall	Non Contributory Qty:	
W-8	Sheetrock wall, painted and smooth	Contributory Qty:	
CL-08	Acoustical ceiling, suspended T-bar frame	Non Contributory Qty:	
D-13	Metal wood-grained panel door with matching casing. Bankers glass panels	Contributory Qty: 1	Marble threshold
F-11	Carpeted floor, on pad	Contributory Qty:	
WN-1	Aluminum replacement window	Non Contributory Qty: 1 pr	with M-16

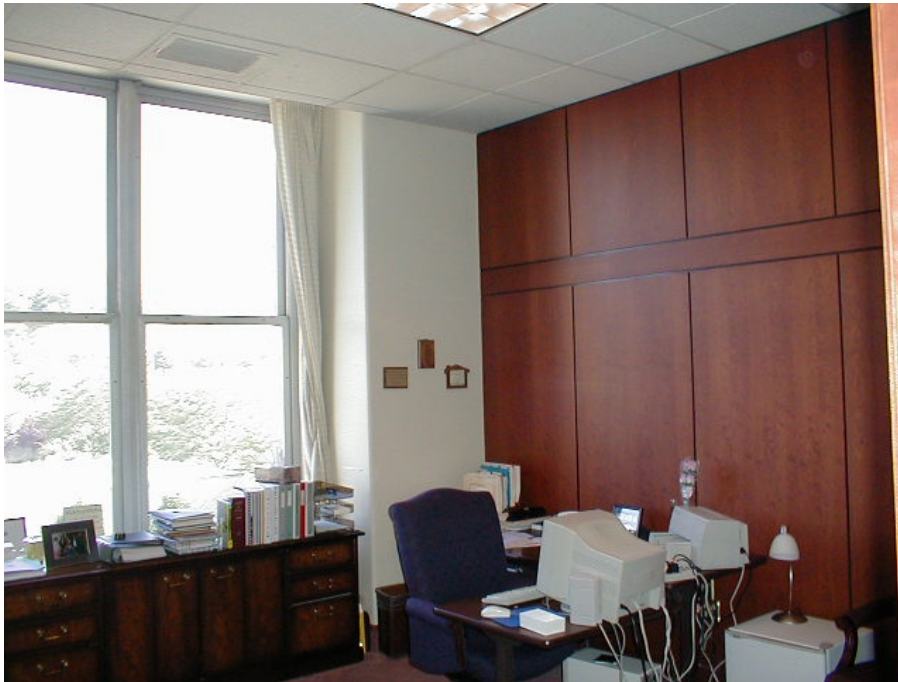
## 360c

Notes Includes 360b thru 360l.

Element	Description	Historical Significance	Notes
W-4	Wood panelled wall	Non Contributory Qty:	
W-18	demountable wall	Non Contributory Qty:	
W-11	Fabric wall, glue-on	Non Contributory Qty:	
SP-3	Wood bookcase, built-in	Non Contributory Qty:	
L-81	Parabolic	Non Contributory Qty:	
W-8	Sheetrock wall, painted and smooth	Contributory Qty:	
CL-08	Acoustical ceiling, suspended T-bar frame	Non Contributory Qty:	
B-12	Carpet base	Non Contributory Qty:	
F-12	Carpeted floor, glue-down	Contributory Qty:	
F-11	Carpeted floor, on pad	Contributory Qty:	
D-13	Metal wood-grained panel door with matching casing. Bankers glass panels	Contributory Qty:	
D-19	Wood slab door with plain metal casing. (demountable wall doors)	Contributory Qty:	
WN-1	Aluminum replacement window	Non Contributory Qty:

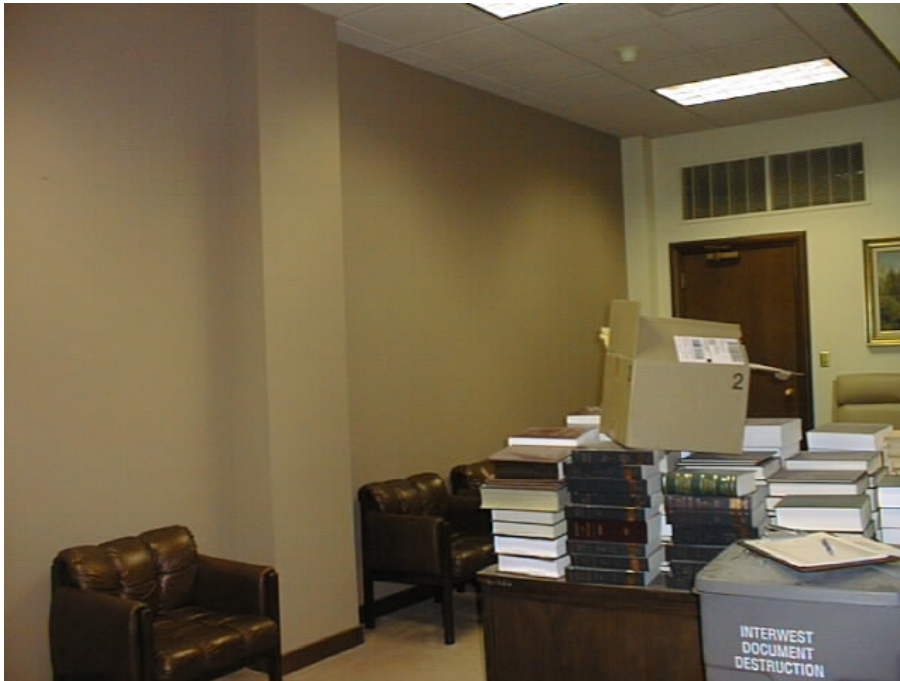
## 361a Senate Filing Room

Element	Description	Historical Significance	Notes
D-01	Wood panel door, decorative wood casing with transom.	Contributory Qty: 2	From 361 (bad staining) and to 360
D-04	Wood panel door, decorative metal wood-grained casing, transom above	Very Significant Qty:	Double doors - to corridor, ceiling lowered to cover transom - allowing for vents/ducts.
B-2	Molded wood base	Contributory Qty:	4" new
CL-08	Acoustical ceiling, suspended T-bar frame	Non Contributory Qty:	
F-12	Carpeted floor, glue-down	Contributory Qty:	
HC-10	vent	Non Contributory Qty:	
HC-7	Duct	Non Contributory Qty:	
L-14	Recessed lights	Non Contributory Qty:	on lowered ceiling
L-81	Parabolic	Non Contributory Qty:	
W-11	Fabric wall, glue-on	Contributory Qty:	North wall
W-8	Sheetrock wall, painted and smooth	Contributory Qty:	Plaster wall

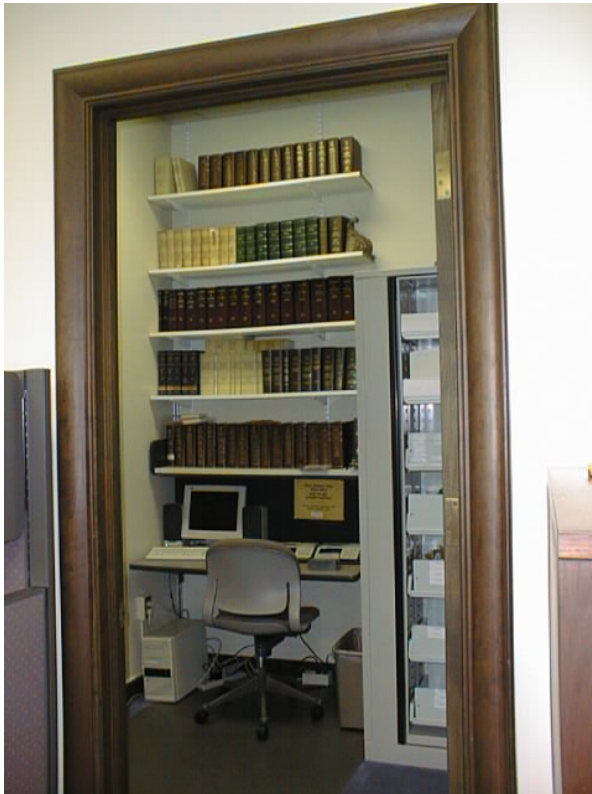
## 361b Senate Listening Room

Element	Description	Historical Significance	Notes
CL-07	Acoustical tile ceiling, glue-on	Non Contributory Qty:	
B-2	Molded wood base	Contributory Qty:	stained
D-02	Wood panel door, wood bollection molding casing	Contributory Qty:	with M-19
F-12	Carpeted floor, glue-down	Contributory Qty:	
L-08	Fluorescent lights	Non Contributory Qty:	
W-8	Sheetrock wall, painted and smooth	Contributory Qty:

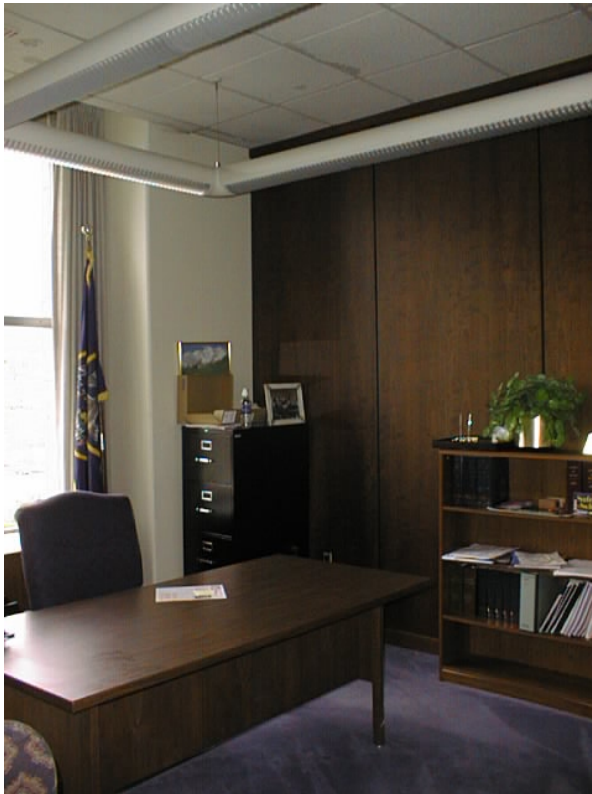
## 362 Supreme Court Office

Notes      Window - variable element.

Element	Description	Historical Significance	Notes
B-12	Carpet base	Non Contributlory Qty:	
B-2	Molded wood base	Contributory Qty:	stained
E-18	Modern speakers	Non Contributory Qty:	
W-4	Wood panelled wall	Non Contributory Qty:	east wall
W-8	Sheetrock wall, painted and smooth	Contributory Qty:	
WN-1	Aluminum replacement window	Non Contributory Qty:      1 pr	with M-16
CL-08	Acoustical ceiling, suspended T-bar frame	Non Contributory Qty:	
D-15	Wood slab door with plain wood casing (simple closet/demountable doors)	Contributory Qty:	with M-6, H-3, WN-7, M-41 to hall
D-24	Wood slab door with wood bollection molding	Contributory Qty:      1	with M-6, H-3 to 360
F-12	Carpeted floor, glue-down	Contributory Qty:	
L-08	Fluorescent lights	Non Contributory Qty:

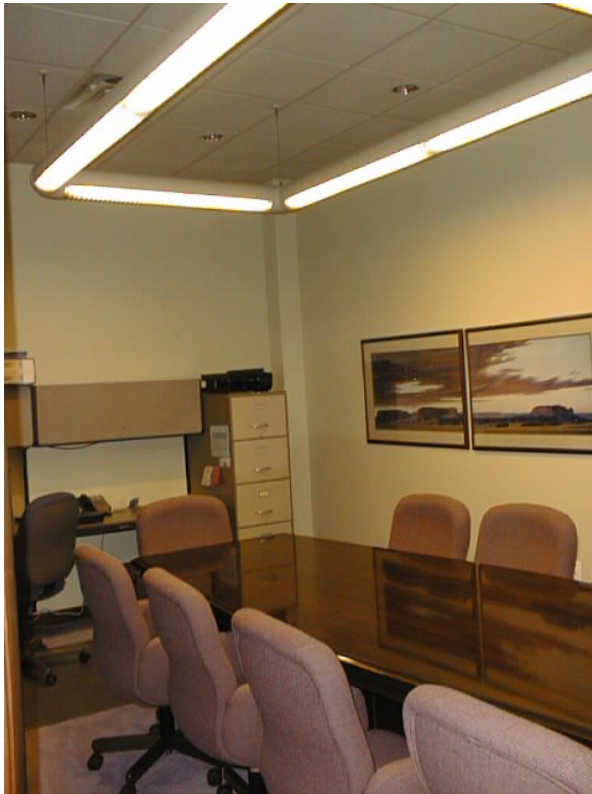
## 363 Senate Conference Room

Element	Description	Historical Significance	Notes
B-2	Molded wood base	Contributory Qty:	stained
CL-08	Acoustical ceiling, suspended T-bar frame	Non Contributory Qty:	
D-15	Wood slab door with plain wood casing (simple closet/demountable doors)	Contributory Qty:	or #20?
F-12	Carpeted floor, glue-down	Contributory Qty:	custom
L-14	Recessed lights	Non Contributory Qty:	
L-82	Pendent Parabolic	Non Contributory Qty:	
W-4	Wood panelled wall	Non Contributory Qty:	
W-8	Sheetrock wall, painted and smooth	Contributory Qty:

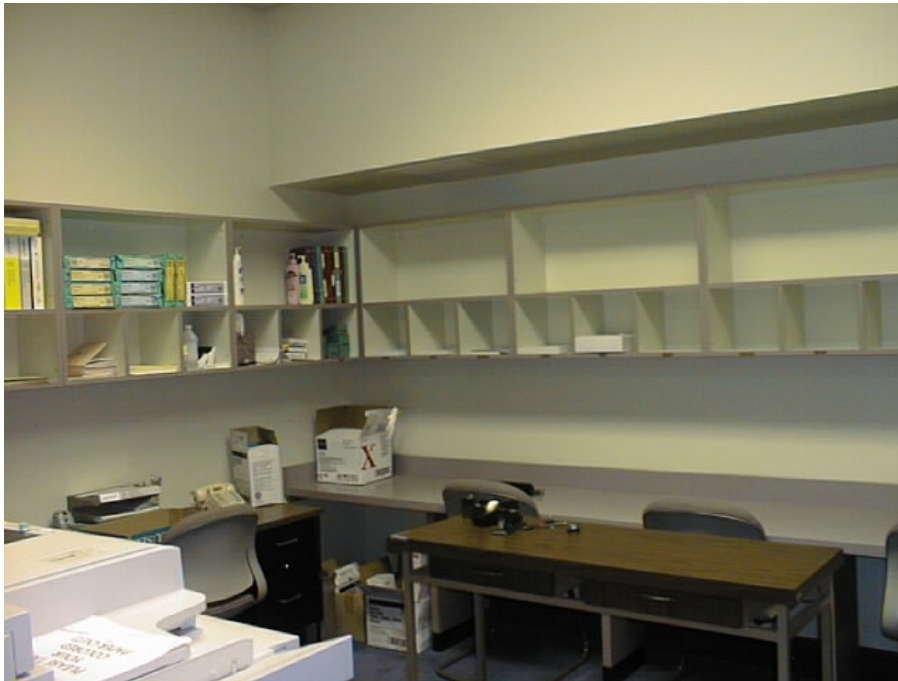
## 364 Senate Copy Room

Notes Includes 365

Element	Description	Historical Significance	Notes
W-7	Plaster wall, painted and smooth	Very Significant Qty:	
B-12	Carpet base	Non Contributory Qty:	
SP-3	Wood bookcase, built-in	Non Contributory Qty:	
W-11	Fabric wall, glue-on	Non Contributory Qty:	specific to room 365
CPP-7	Plaster pilaster, painted	Significant Qty:	specific to room 365
WN-3	Interior transom	Non Contributory Qty:	specific to room 365
B-2	Molded wood base	Contributory Qty:	Stain
CL-08	Acoustical ceiling, suspended T-bar frame	Non Contributory Qty:	
D-02	Wood panel door, wood bollection molding casing	Contributory Qty:	with M-19, WN-3, north
L-08	Fluorescent lights	Non Contributory Qty:	
W-8	Sheetrock wall, painted and smooth	Contributory Qty:

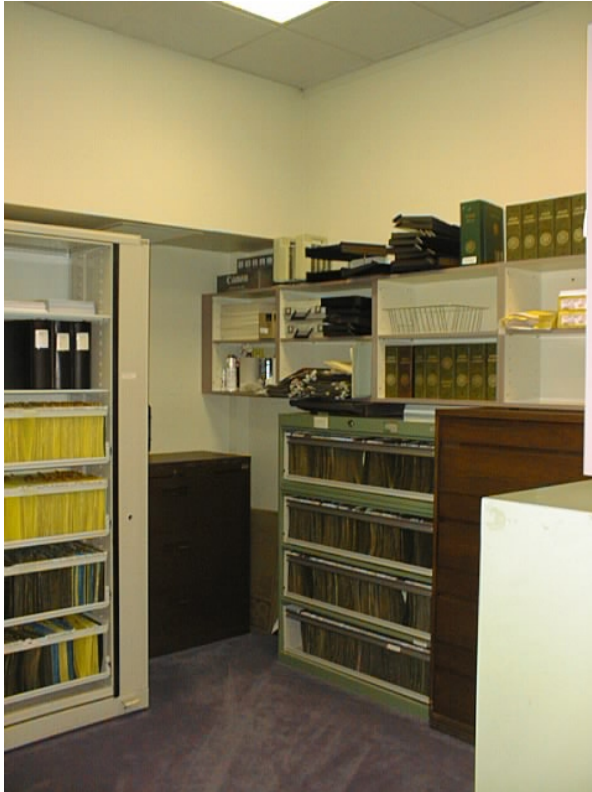
## 365 Senate File Room

Element	Description	Historical Significance	Notes
B-12	Carpet base	Non Contributory Qty:	
B-2	Molded wood base	Contributory Qty:	
CL-08	Acoustical ceiling, suspended T-bar frame	Non Contributory Qty:	
D-13	Metal wood-grained panel door with matching casing. Bankers glass panels	Contributory Qty:	with M-19
F-12	Carpeted floor, glue-down	Contributory Qty:	
HC-7	Duct	Non Contributory Qty:	south
L-08	Fluorescent lights	Non Contributory Qty:	
NHF-5	Storage/filing equipment	Contributory Qty: 3	Supreme Equipment Systems, New York
W-8	Sheetrock wall, painted and smooth	Contributory Qty:

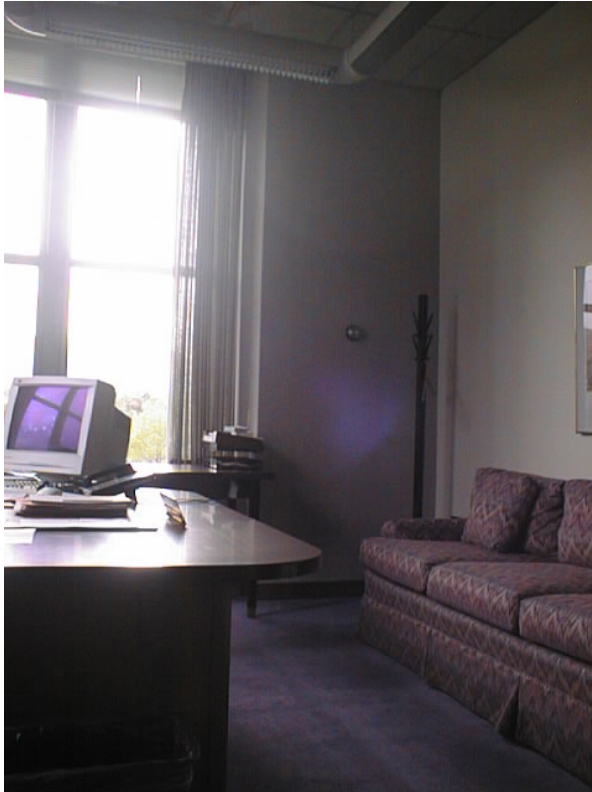
## 368 Majority Whip

Element	Description	Historical Significance	Notes
D-14	Metal wood-grained panel door with decorative wood casing. Bankers glass panels	Very Significant Qty:	Main Entry
D-02	Wood panel door, wood bollection molding casing	Significant Qty:	Door adjioning offices
B-2	Molded wood base	Contributory Qty:	Stain
CL-08	Acoustical ceiling, suspended T-bar frame	Non Contributory Qty:	
F-12	Carpeted floor, glue-down	Contributory Qty:	
HC-7	Duct	Non Contributory Qty:	south, metal lower (?) above door
L-82	Pendent Parabolic	Non Contributory Qty:	
W-11	Fabric wall, glue-on	Contributory Qty:	
W-8	Sheetrock wall, painted and smooth	Contributory Qty:	
WN-1	Aluminum replacement window	Non Contributory Qty: 1 pr	with M-16

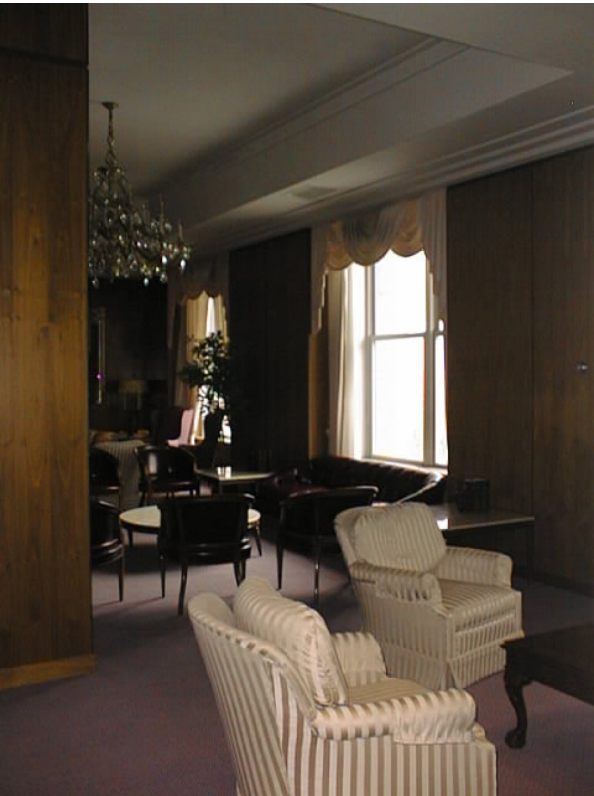
# 370c Senate Lounge

Element	Description	Historical Significance	Notes
B-2	Molded wood base	Contributory Qty:	Stained
SP-18	drapery	Qty:	
CL-14	Modern coffered ceiling, in four stages	Contributory Qty:	
D-05	Metal wood-grained panel door with matching casing	Significant Qty: 2	with M-6, B-7, to chamber
F-12	Carpeted floor, glue-down	Contributory Qty:	
L-14	Recessed lights	Non-Contributory Qty: 1	
L-27	Ceiling Light - simple bulb	Contributory Qty: 1	
W-4	Wood panelled wall	Non Contributory Qty:	on CPP, too; wood panelled wall and columns
WN-1	Aluminum replacement window	Non-Contributory Qty: 3 pr	with M-16

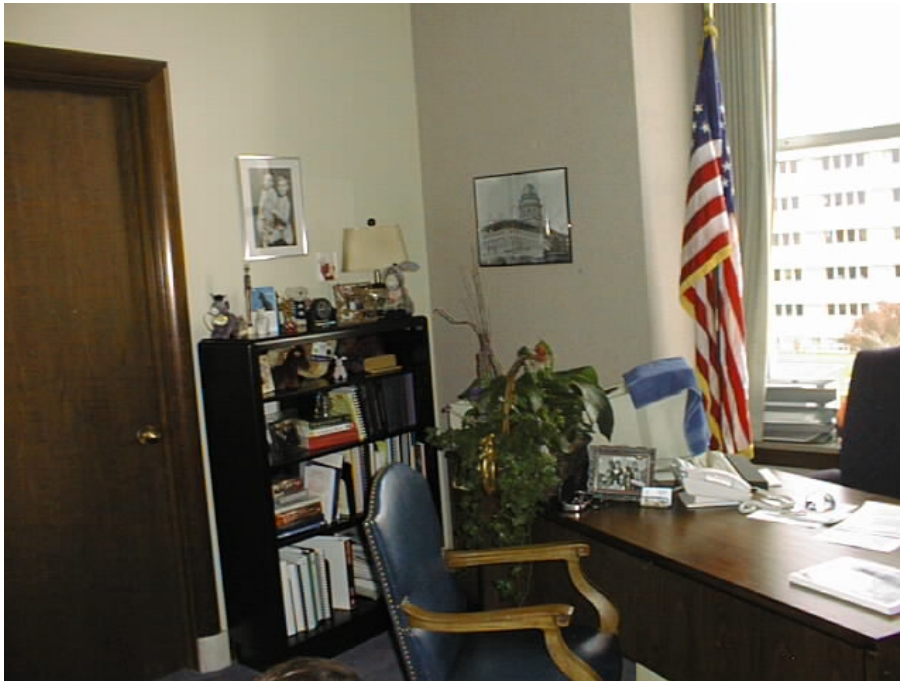
## 371 Senate Minority Whip

Element	Description	Historical Significance	Notes
D-02	Wood panel door, wood bollection molding casing	Significant Qty:	Door adjoining room with 372
B-2	Molded wood base	Contributory Qty:	Stain
CL-08	Acoustical ceiling, suspended T-bar frame	Non Contributory Qty:	
D-14	Metal wood-grained panel door with decorative wood casing. Bankers glass panels	Contributory Qty:	with M-42, B-7, H-3
F-12	Carpeted floor, glue-down	Contributory Qty:	
L-82	Pendent Parabolic	Non Contributory Qty:	hanging parabolic
W-11	Fabric wall, glue-on	Contributory Qty:	
W-8	Sheetrock wall, painted and smooth	Contributory Qty:	
WN-1	Aluminum replacement window	Non Contributory Qty: 1 pr	with M-16

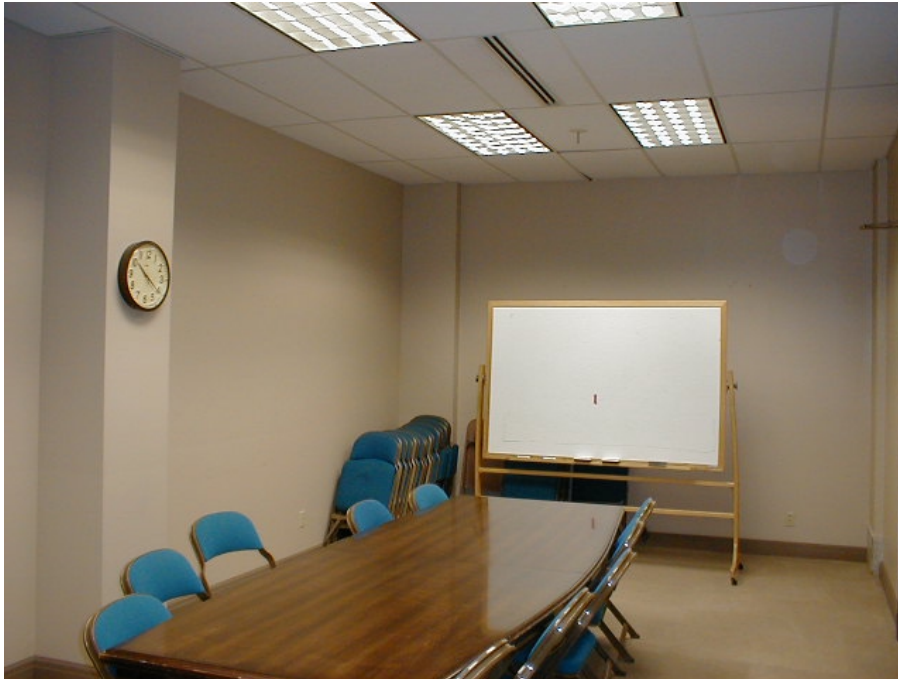
## 407 Conference Room

Element	Description	Historical Significance	Notes
B-1	Gray marble base, 12" polished	Very Significant Qty:	at columns and pilasters, South wall only
B-6	Plaster base, painted	Contributory Qty:	
CL-08	Acoustical ceiling, suspended T-bar frame	Non-Contributory Qty:	
CPP-5	Oolite pilaster, painted	Significant Qty:	
D-04	Wood panel door, decorative metal wood-grained casing, transom above	Significant Qty:	With transom, metal casing - wood-grained
F-14	Carpet tiles	Non-Contributory Qty:	
L-81	Parabolic	Non-Contributory Qty:	
W-7	Plaster wall, painted and smooth	Contributory Qty:	South and East walls
W-8	Sheetrock wall, painted and smooth	Contributory Qty:	north, east and west walls

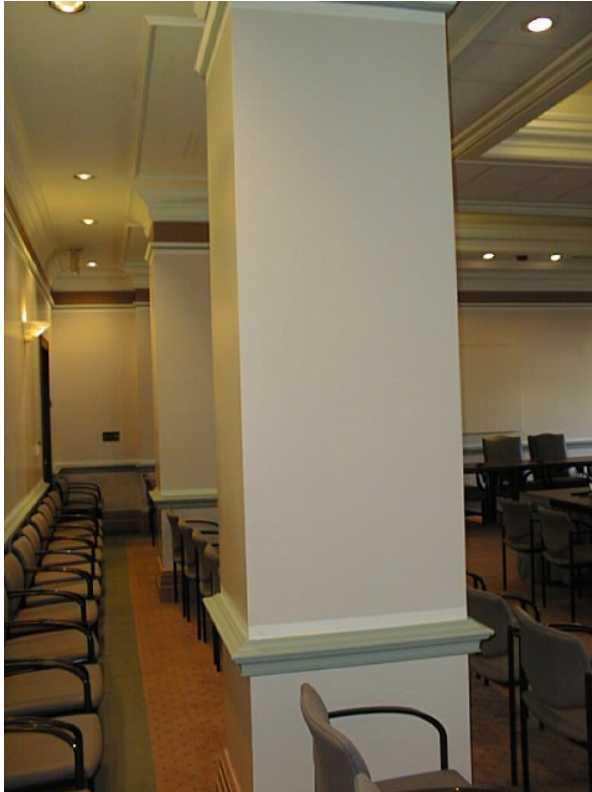
## 414 Committee Room

Notes includes 414a and 416.

Element	Description	Historical Significance	Notes
CR-2	Plaster cornice: crown molding, classical and simple	Non Contributory Qty:	
D-25	Wood panel door with decorative wood casing	Contributory Qty:	
D-07	Wood Panel door with decorative metal wood-grained casing	Contributory Qty:	
W-7	Plaster wall, painted and smooth	Contributory Qty:	
W-8	Sheetrock wall, painted and smooth	Contributory Qty:	
CL-06	Sheetrock ceiling, painted	Non Contributory Qty:	perimeter only
B-2	Molded wood base	Non-Contributory Qty:	
CL-08	Acoustical ceiling, suspended T-bar frame	Non Contributory Qty:	
L-12	Indirect cove lighting	Non Contributory Qty:	
L-22	Wall sconce (new) frosted glass, cone-shaped	Contributory Qty: 5	
L-14	Recessed lights	Non Contributory Qty:	
F-11	Carpeted floor, on pad	Contributory Qty:	
M-11	Wood chair rail	Non Contributory Qty:	
M-12	Wood picture rail	Non Contributory Qty:	
WN-1	Aluminum replacement window	Contributory Qty:

M-20	light cove	Non Contributory Qty:
W-24	Accordian dividing wall, painted and molded as wall	Non Contributory Qty:

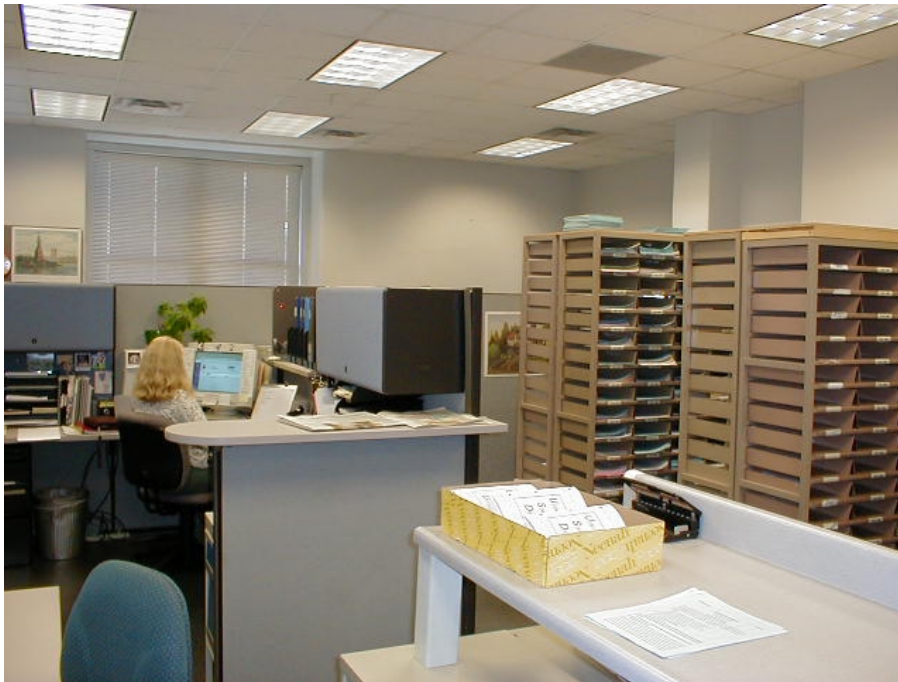
## 419 Bill Print Room

**Notes** Room wraps around the senate gallery. Though considered to be the same room. A wall divides the space into 419a and 420. In 419 the ceiling has been lowered over the door, covering the transom. Appears to house vents/ducts.

Element	Description	Historical Significance	Notes
B-1	Gray marble base, 12" polished	Very Significant Qty:	The marble base - covers the area the tile mosaics covers.
B-6	Plaster base, painted	Contributory Qty:	
CL-08	Acoustical ceiling, suspended T-bar frame	Non-Contributory Qty:	
CPP-7	Plaster pilaster, painted	Significant Qty:	
D-12	Metal wood-grained panel door with matching casing. Decorative louver transom	Contributory Qty:	Single door at West entry and Double door at East entry. Both doors face the south.. The door to the 420 side is a double door with copper/brass Kick-plates.
E-12	electrical box	Non-Contributory Qty:	within one of the side rooms varies
F-12	Carpeted floor, glue-down	Non-Contributory Qty:	
F-14	Carpet tiles	Non-Contributory Qty:	print area specific to 420
F-16	Concrete floor, painted	Non-Contributory Qty:	unsure if this is exact - but it looks like it! specific to 420

<b>F-2</b>	Tile floor, hex & square, mosaic	Significant Qty:	this is only seen on the east corridor, it stops and the flooring is then unsure. It might have been the painted concrete. It is now tiled carpet glue down. The boarder pattern matches that of the greek keys specific to 420
<b>M-16</b>	Marble window sill, original, with molded wood skirt	Contributory Qty:	
<b>W-7</b>	Plaster wall, painted and smooth	Contributory Qty:	this wall is the senate gallery
<b>WN-1</b>	Aluminum replacement window	Non Contributory Qty:	
<b>WN-8</b>	Interior sidelight window, metal	Non-Contributory Qty:	window wall - used as the divider between the office and the work room areas.
<b>L-81</b>	Parabolic	Non-Contributory Qty:	
<b>D-19</b>	Wood slab door with plain metal casing. (demountable wall doors)	Qty:	located a the new wall dividing rooms 419/420. This wall consits of the door and 3 door sized glass panels.

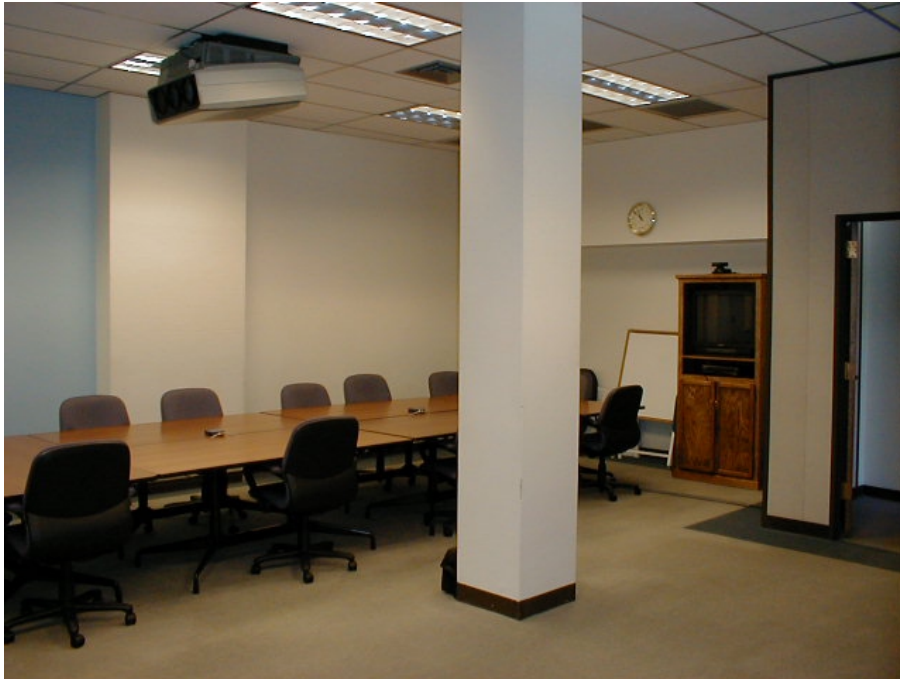
423

Element	Description	Historical Significance	Notes
B-1	Gray marble base, 12" polished	Very Significant Qty:	on the columns in the conference room 17 1/2 "
B-4	Rubber/vinyl base	Non-Contributory Qty:	put over the marble base on the columns in the conference room
B-6	Plaster base, painted	Contributory Qty:	
CL-08	Acoustical ceiling, suspended T-bar frame	Non-Contributory Qty:	
CPP-7	Plaster pilaster, painted	Significant Qty:	17 1/2 "
D-09	Wood slab door with decorative metal-wood grained casing, transom above	Contributory Qty:	
F-14	Carpet tiles	Non-Contributory Qty:	
L-08	Fluorescent lights	Non-Contributory Qty:	parabolic lights
M-6	Metal wood-grained casing w/ fancy profile	Contributory Qty:	
W-18	demountable wall	Non Contributory Qty:	
WN-10	Transom grille, ornamental	Non-Contributory Qty:	
WN-4	Wood-grained, wire glass, awning-type transom	Contributory Qty:

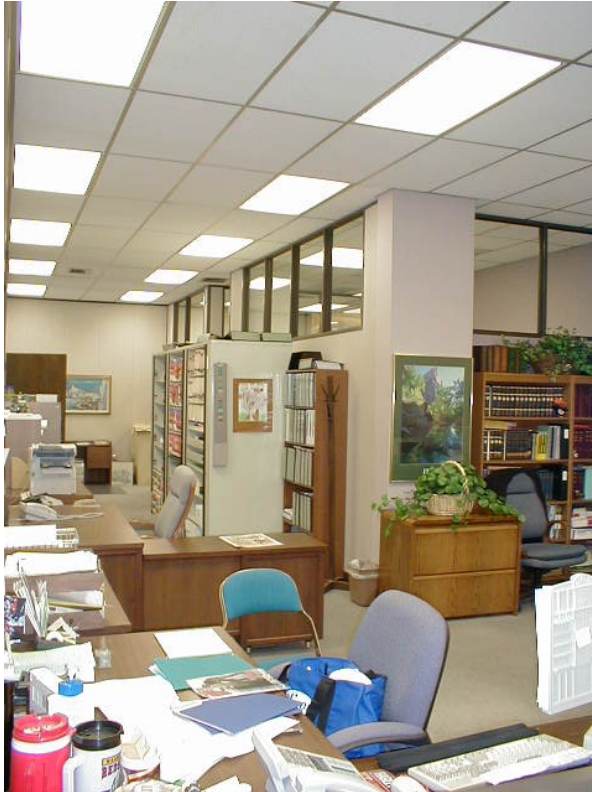
## Office/ Legislative Fiscal Analyst

**Notes** This room description includes all rooms within the department.423-445. Elements and information are the same though this area is split into two preservation ranks. Through the west entrance the ceiling is lowered, covering the transom, and contains one recessed light. After that small vestibule the ceiling is raised to the normal height, except in the conference room where it extends along the west wall creating a 1-2' indented wall area. Windows are an alternate elements - obviously only in offices along the North wall. Also used to house the art board room 427 area used to be the Engineers office

Element	Description	Historical Significance	Notes
L-14	Recessed lights	Non-Contributory Qty:	The office only contains one recessed light - has never been on during our surveying. May need to be replaced.
D-12	Metal wood-grained panel door with matching casing. Decorative louver transom	Qty:	at the west entrance only. Opens to a private vestibule - lowered ceiling.
W-7	Plaster wall, painted and smooth	Very Significant Qty:	
W-8	Sheetrock wall, painted and smooth	Contributory Qty:	In conference room, 423, only.
D-19	Wood slab door with plain metal casing. (demountable wall doors)	Non - Contributory Qty:	Placed on all demountable walls. Private offices/space separation accomplished through these alone.
D-09	Wood slab door with decorative metal-wood grained casing, transom above	Contributory Qty:	
CPP-7	Plaster pilaster, painted	Significant Qty:	
D-10	Metal wood-grained panel door with matching casing. Bankers glass panel and transom	Contributory Qty:

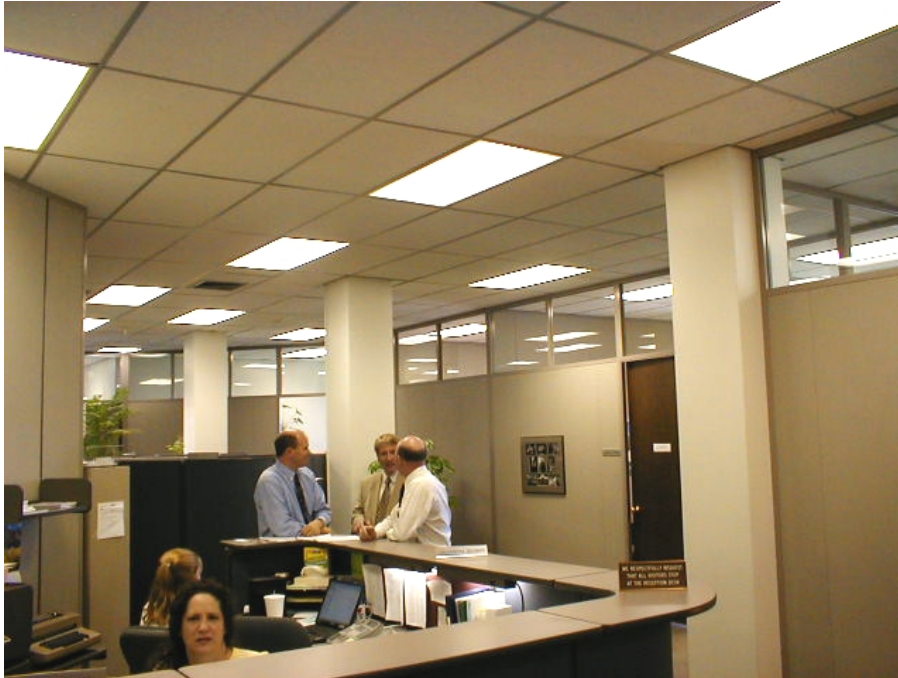
## 436 Legislative Research

Notes Includes the entire department space.

Element	Description	Historical Significance	Notes
MS-3	Fire hose cabinet, glass, metal, recessed in wall	Qty:	
D-01	Wood panel door, decorative wood casing with transom.	Qty: 1	
D-04	Wood panel door, decorative metal wood-grained casing, transom above	Qty: 2	at main entrance
D-19	Wood slab door with plain metal casing. (demountable wall doors)	Qty:	as part of the office demountable wall system, for private offices
B-1	Gray marble base, 12" polished	Very Significant Qty:	Around the doors and on oolite slab walls
B-4	Rubber/vinyl base	Non-Contributory Qty:	
B-6	Plaster base, painted	Contributory Qty:	placed over plaster wall. North in the front entry area
CL-08	Acoustical ceiling, suspended T-bar frame	Non-Contributory Qty:	
CPP-7	Plaster pilaster, painted	Significant Qty:	
D-10	Metal wood-grained panel door with matching casing. Bankers glass panel and transom	Contributory Qty: 3	
F-14	Carpet tiles	Non-Contributory Qty:

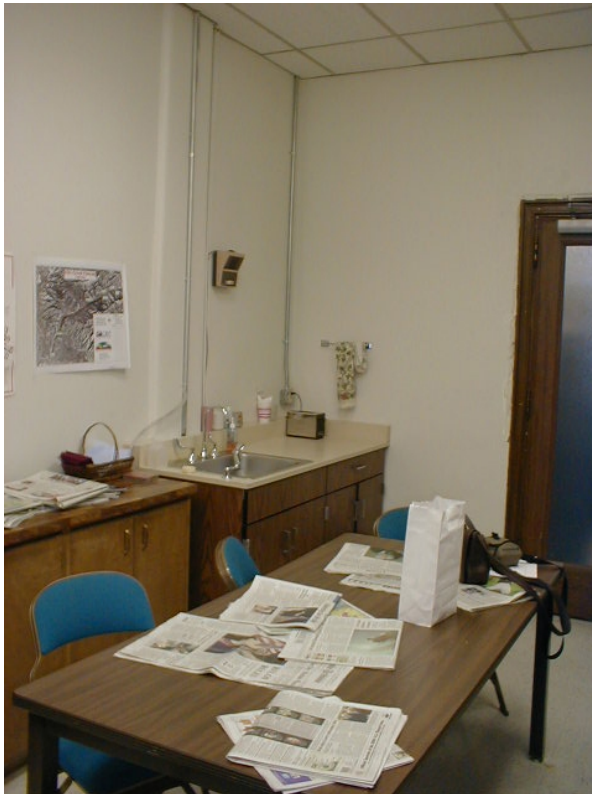
Notes These rooms are located on the North side of the Supreme Court Chamber gallery space.

Element	Description	Historical Significance	Notes
B-4	Rubber/vinyl base	Qnty:	
F-10	Vinyl floor	Non Contributory Qnty:	
W-2	Oolite slab wall, painted	Qnty:	West wall of computer room
W-7	Plaster wall, painted and smooth	Qnty:	south Wall - connecting wall to Supreme Court Chamber/gallery. Also used on the north and east walls. Though unsure if they are original. They both have somewhat historic doors.
W-8	Sheetrock wall, painted and smooth	Qnty:	dividing the lunch room and computer rooms
D-13	Metal wood-grained panel door with matching casing. Bankers glass panels	Qnty: 2	Unsure if they are original. Most probably moved from a different location.
D-15	Wood slab door with plain wood casing (simple closet/demountable doors)	Qnty:	door to computer/server room
CL-08	Acoustical ceiling, suspended T-bar frame	Qnty:	
L-08	Fluorescent lights	Qnty:	
B-4	Rubber/vinyl base	Qnty:

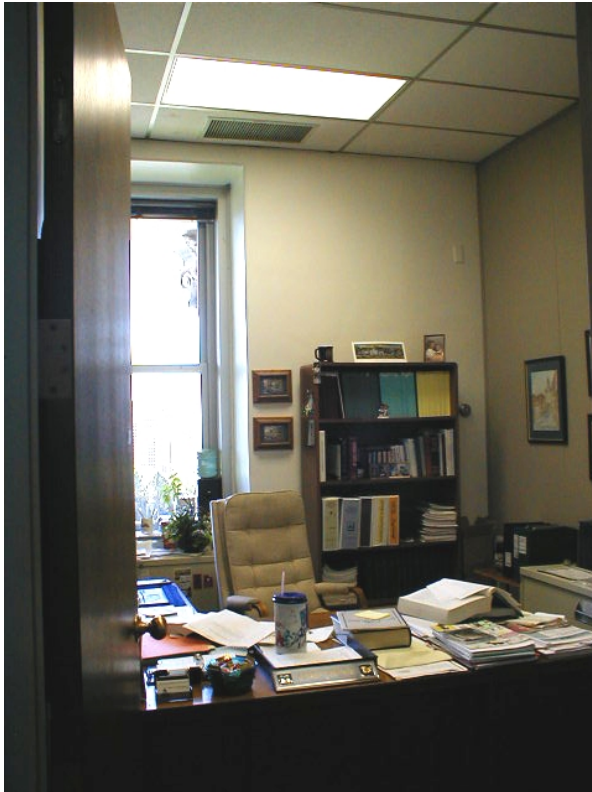
Element	Description	Historical Significance	Notes
M-6	Metal wood-grained casing w/ fancy profile	Contributory Qty:	
B-1	Gray marble base, 12" polished	Very Significant Qty:	
L-08	Fluorescent lights	Non Contributory Qty:	
W-18	demountable wall	Non Contributory Qty:	
F-14	Carpet tiles	Non-Contributory Qty:	
B-4	Rubber/vinyl base	Non-Contributory Qty:	
B-6	Plaster base, painted	Contributory Qty:	
CL-08	Acoustical ceiling, suspended T-bar frame	Non-Contributory Qty:	
CPP-7	Plaster pilaster, painted	Significant Qty:	
D-09	Wood slab door with decorative metal-wood grained casing, transom above	Contributory Qty:	
WN-4	Wood-grained, wire glass, awning-type transom	Contributory Qty:	
WN-10	Transom grille, ornamental	Contributory Qty:	
B-1	Gray marble base, 12" polished	Very Significant Qty:	
B-4	Rubber/vinyl base	Non-Contributory Qty:	
B-6	Plaster base, painted	Contributory Qty:
